# Appendix 9

## Cultural Heritage

## A9.1. Cultural Heritage Overview

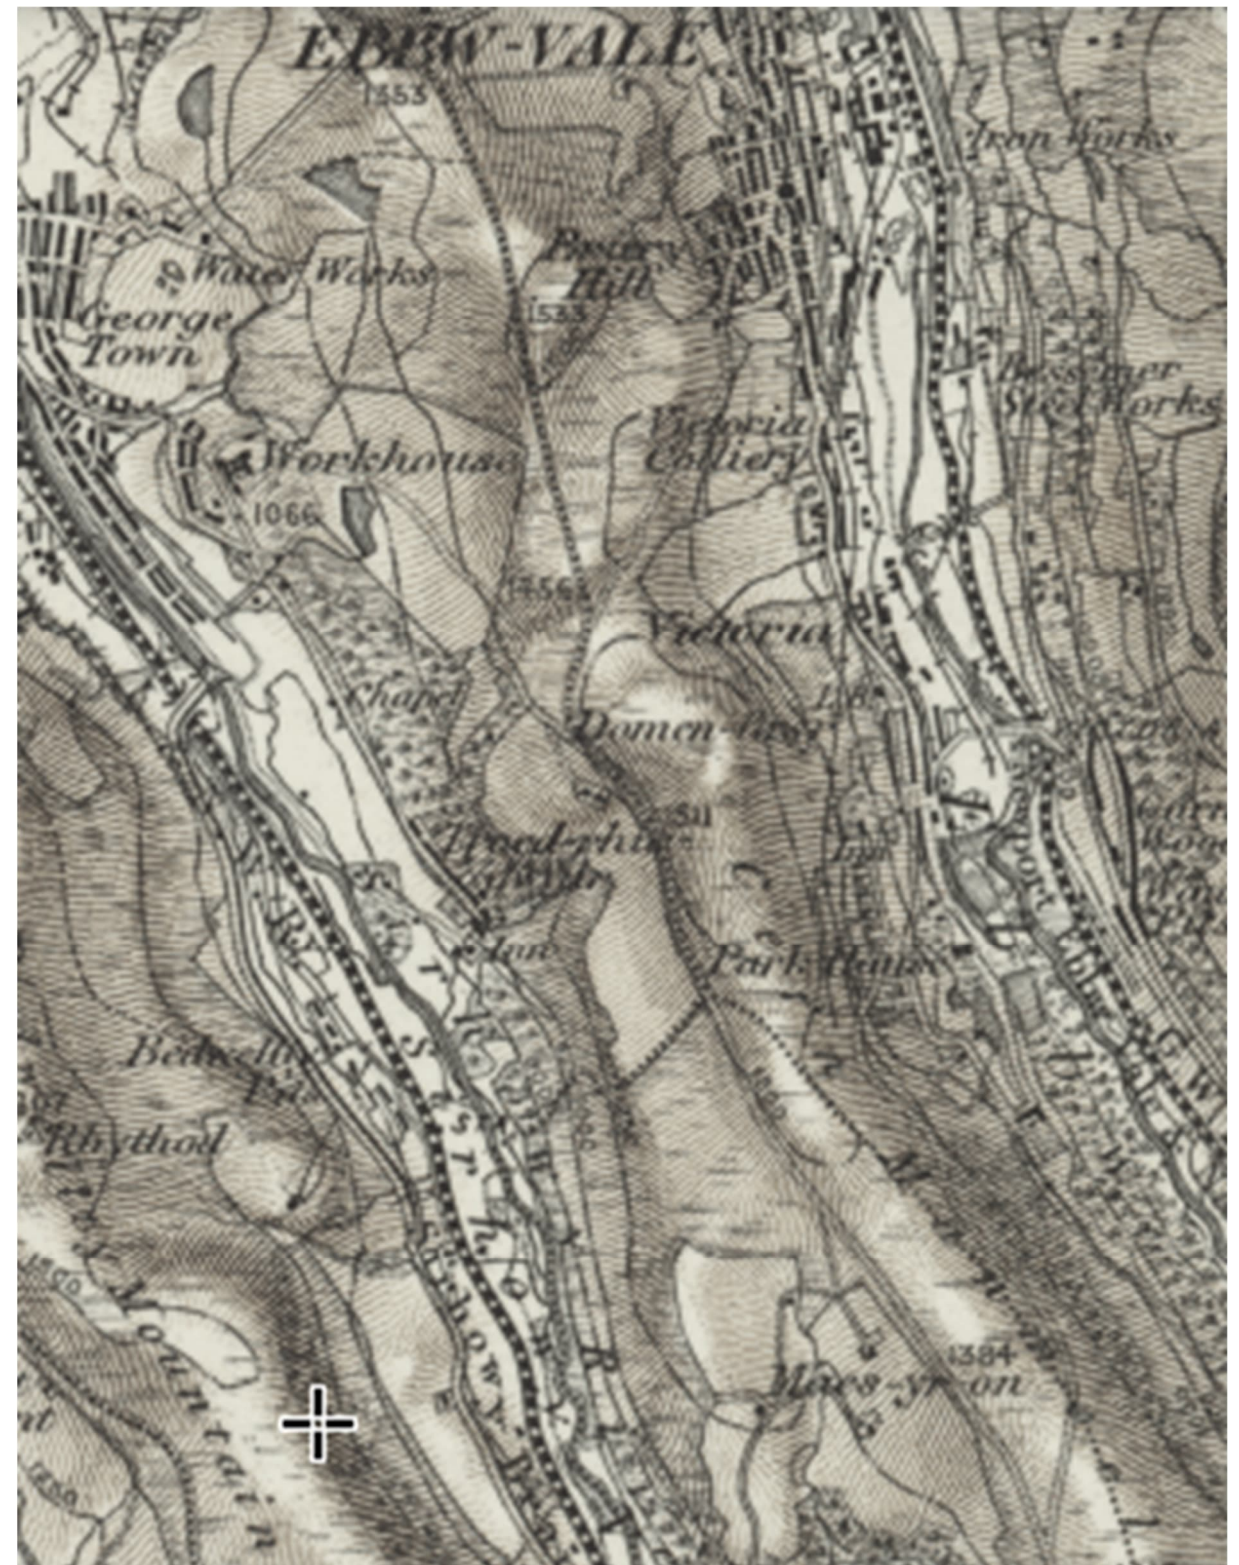
Figure A9.1.1 First edition Ordnance Survey map at 1" to the mile scale published 1885

- A9.1.17. The Ebbw Valley Steelworks was at one point the largest steelworks in Europe (Figure A9.1.1). It was opened in 1790 by Jeremiah Homfray, who later sold it in 1796 to the Harford family, who expanded operations by building three new blast furnaces, and by buying an additional three from Sirhowy works in 1818. In 1842 the Harford family were bankrupt, and the running of the steelworks was handed over to trustees. In 1844, it was overtaken by Abraham Derby, who formed the Ebbw Vale Company Ltd. The company expanded rapidly, and brought the nearby Victoria Ironworks (1848), the Pentwyn Ironworks (1858), and the Pontypool Ironworks (1872). In 1868, a Bessemer plant was constructed, and steel production began. The company was reformed as the Ebbw Valley Steel, Iron, and Coal Company Ltd in 1868. Issues with financiers (who did not appear to fully understand the iron and steel industry) lead to the closing of the Pentwyn site in 1868 and Sirhowy and Abersychan in 1882 and 1883.

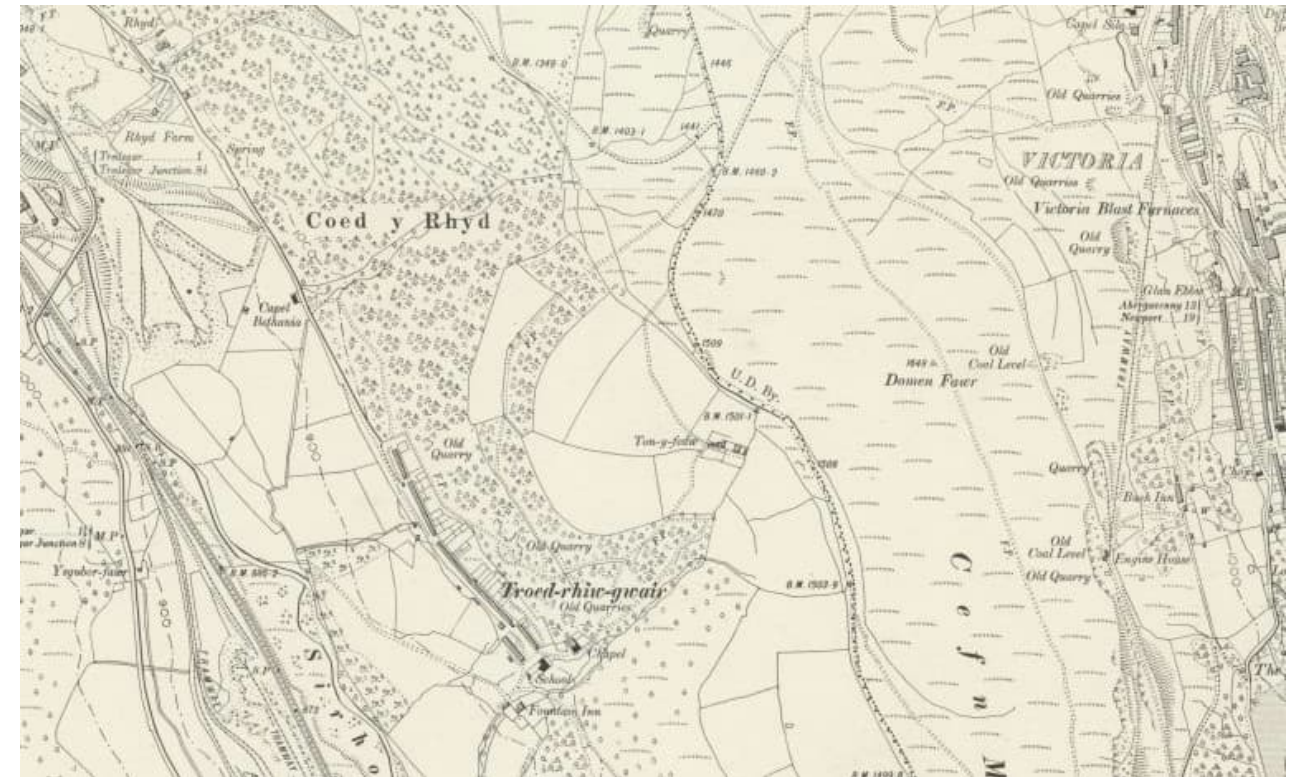
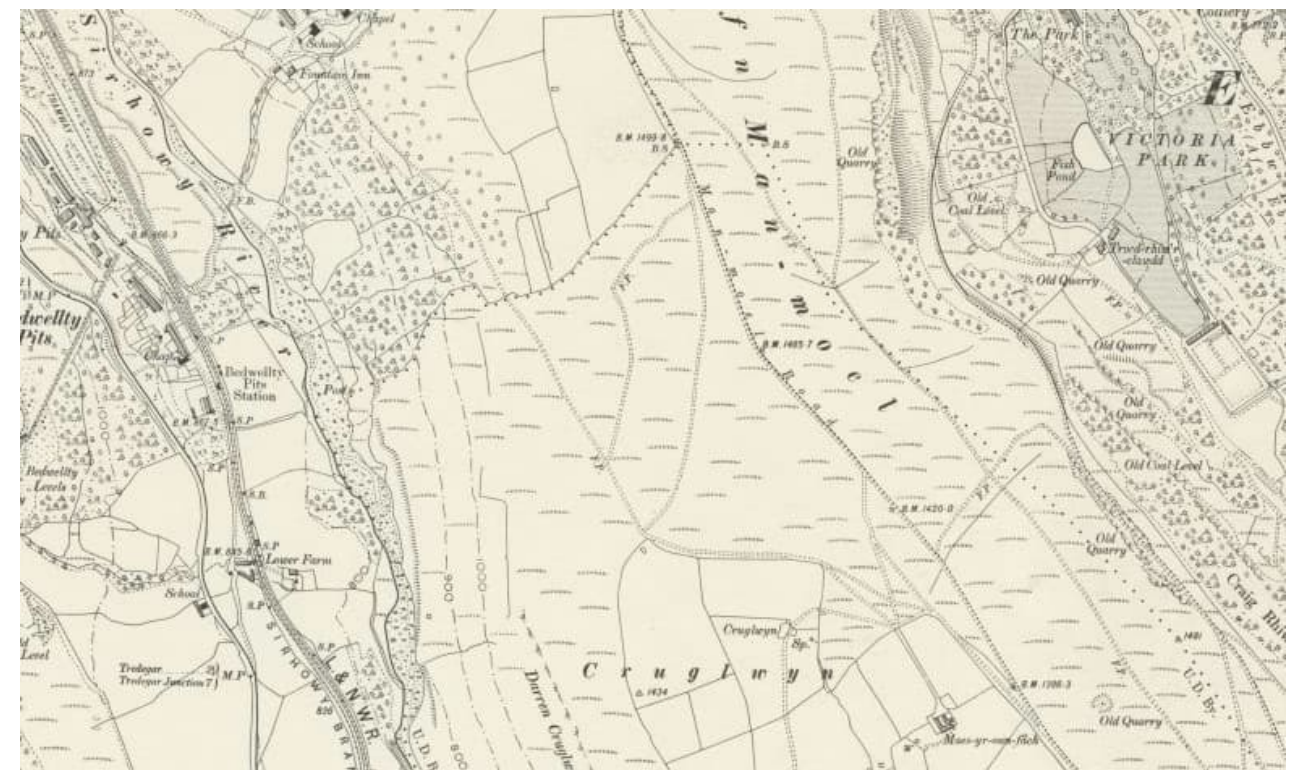
Figure A9.1.2 First edition Ordnance Survey mapping at 25" to the mile scale from 1888 showing the site and historic assets (in four parts from north - south for better clarity)

- A9.1.20. The Victoria Colliery consists of 16 mines producing coal and iron ore to supply the Victoria Ironworks owned by Ebbw Vale Steel, Iron, and Coal company Ltd (Figures A9.1.2 and A9.1.3). The original shaft was sunk to a depth 690 feet and was the only shaft in this mine that produced coal and iron from 3 different levels. It was completed in 1846 and additional shafts were opened.

- A9.1.26. The Victoria Ironworks were built in 1836 by the Monmouthshire Iron and Coal company and consisted of three blast furnaces and puddling mills (Figure 9-1-2). It was leased to Ebbw Valley company in 1848.

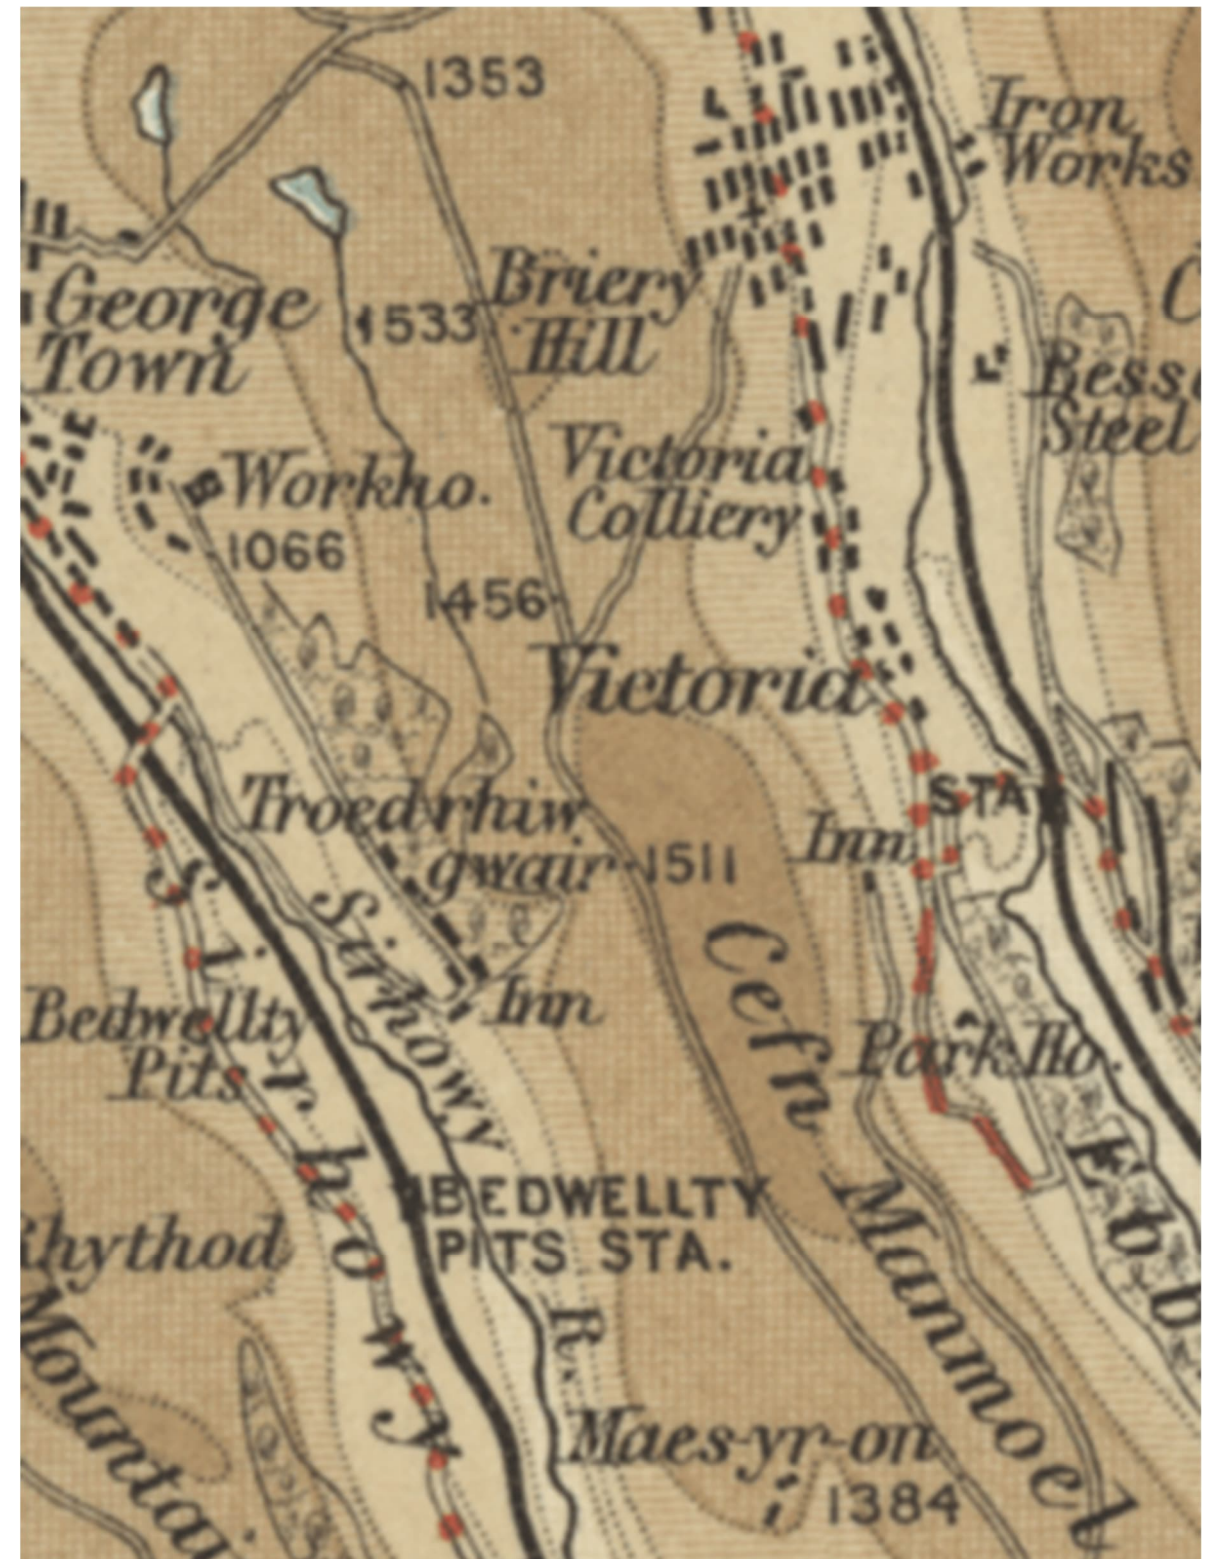
Figure A9.1.4 1907 Bartholomew's half inch to the mile scale map of the area

- A9.1.27. Bedwellty Pits was created in 1850 by the Tredegar Iron and Coal Co. Ltd (Figure A9.1.4). The first pit was quite successful, to the point a second pit was needed. Eventually, the originally colliery was too far from the shaft itself to make economic sense to continue using this shaft to mine the coal, so a second pit, Bedwellty pit No. 2 or the McLaren Colliery, was sunk. It would close in 1939, and pit no.1 would close in 1941.

- A9.1.29. The workhouse was constructed in 1852 in an elevated position near Georgetown, Tredegar (Figure A9.1.4). It originally held over 300 inmates and was constructed of mainly stone in a shortened version of the cruciform design. It contained two south exercise yards which had another yard in between the two. This middle yard was presumably used for access. Inmates in the workhouse included adults and children as young as 1 who were suffering from conditions such as leprosy, crippled limbs, blindness, and poor mental health or disabilities. As with other workhouses, entire families were contained within the workhouse. Former employment of adults within the workhouse included musician, miner, gardener, brewer, puddler, iron worker, and charwoman. Occupants were not necessarily from the immediate surrounding area with the 1881 consensus (recording 260 residents) showing birthplaces such as Bristol, Cornwall, Ireland, and India.

A9.1.39. Park House, also known as Victoria House, was a house built in 1851, rebuilt in 1881 and then abandoned in 1909 due to subsidence (Figure A9.1.4). The following extract shows the issues that the house faced: 'Victoria House, 1851, where the Ebbw Vale Manager lived, had a park of 23 acres in which snipe and other game were strictly preserved, a fishpond of 1 1/2 acres, an ice-house, lawns and ornamental gardens... in time the park was overwhelmed by great heaps of colliery waste and furnace slag which have long since buried its lawns and trees'. The 1900's OS maps shows a large area called Victoria Park, with what appears to be some fairly large buildings in it labelled The Park. These are probably the house and stables, located fairly close the boundary line. Just outside of the boundary line, directly north of the buildings, is a small building labelled lodge. To the east of the lodge, within the park's boundaries, is a large lake labelled fish pond. There is also a railway line running through the length of the boundaries, with the Waun-Lwyd Colliery in the centre. Located to the north of The Park, is a school, chapel, St. Mary's church, and Victoria Station. Outside of the boundaries to the north is the Bush Inn. To the south of The Park, is several old quarries, woodland, a large lake labelled fishpond, and some buildings labelled Trowed-Rhite'r-Clawdd, which is possibly a farm. In modern day, the house and grounds have all been developed upon. Some presence of the old estate remains, one of the roads through where the garden once was, has been called park road, and a housing development to the east of the park has been called Garden City. The Park Road Methodist Chapel, located within the Garden City housing estate, was constructed in 1838 and was rebuilt in 1854. It was closed in 1982 due to issues with dry rot. The Park Hotel, now closed, may have been influenced by Victoria Park.

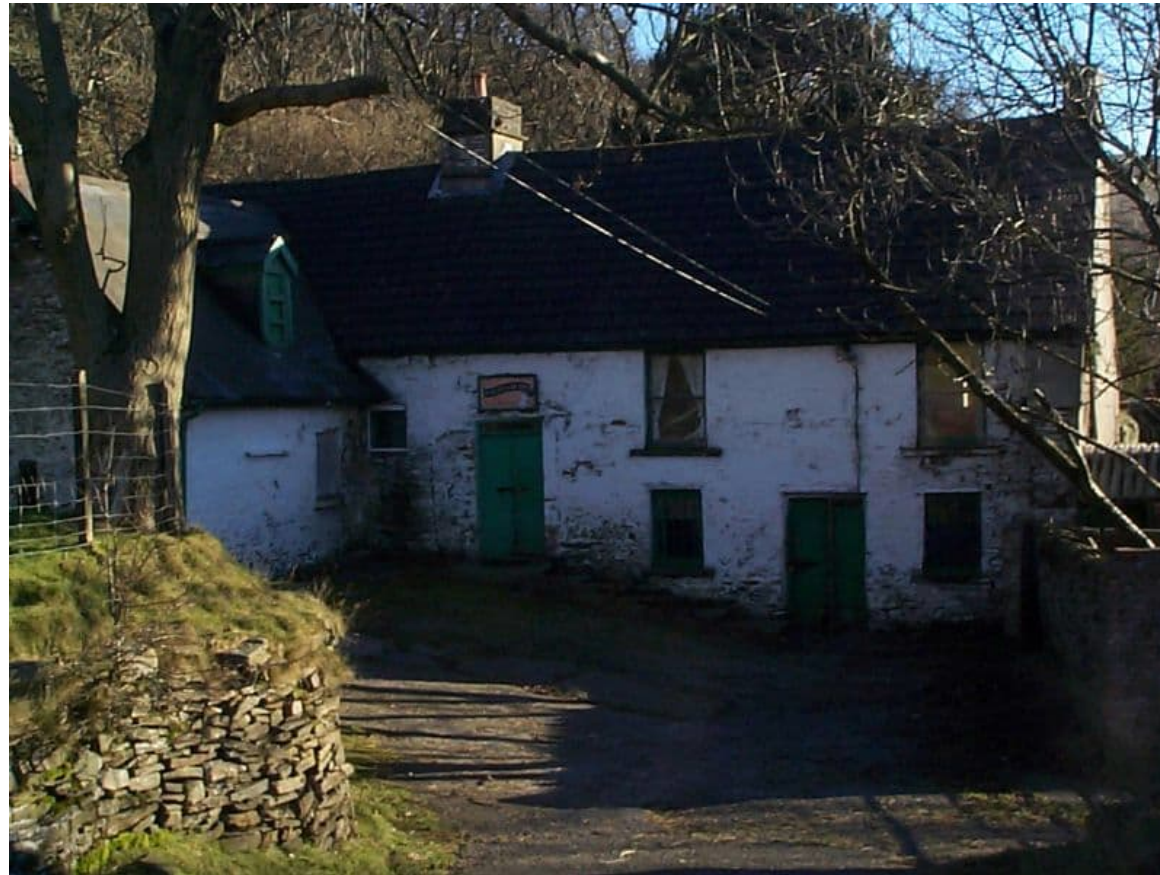
Figure A9.1.5: Exterior of The Fountain Inn, courtesy of British Listed Buildings

A9.1.36. The 1900 OS map shows The Fountain Inn, near Trowdrhiw-Gwar. It was listed as a Grade II listed building in 1989. It is an early 17th C. farmhouse with barns and stables which was added to and converted in the later 19th C. for use as a public house for the mining community (Figure A9.1.5). It was listed as it is a rare example of the transformation of the valleys and the shifting employment in the area.

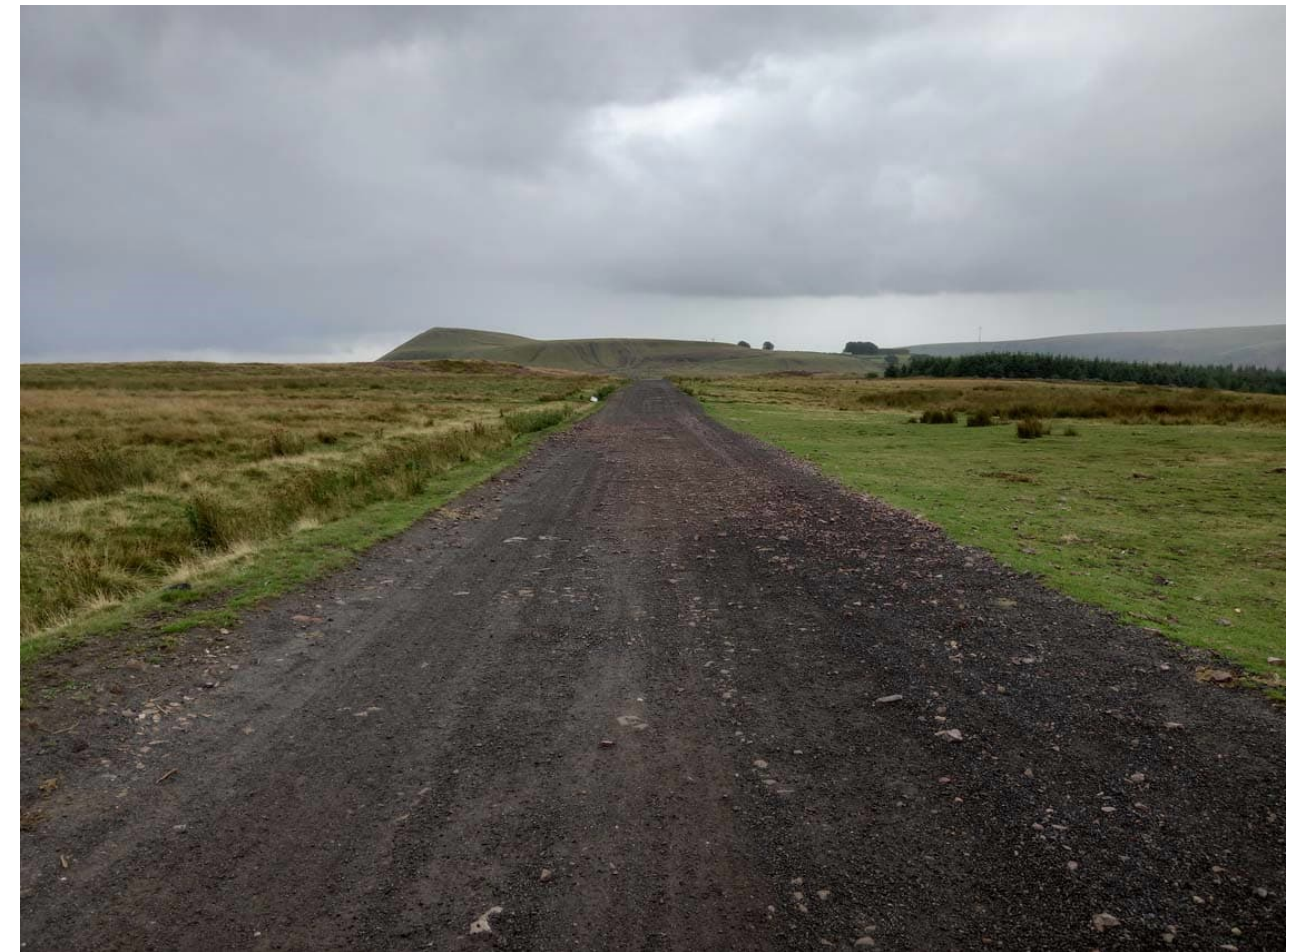
Figure A9.3.1: View of Domen Fawr from the north

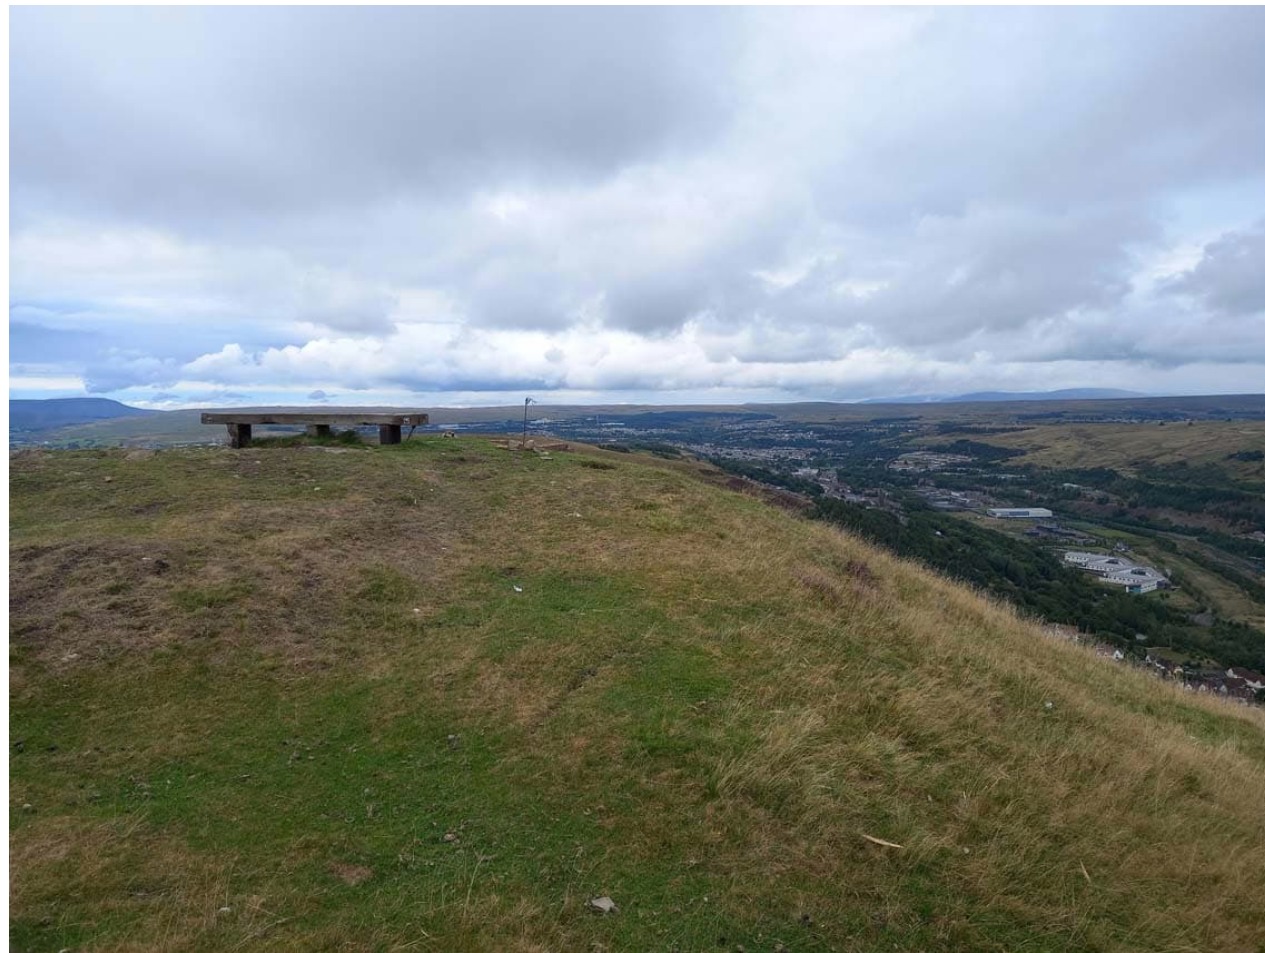
Figure A9.3.2: Domen Fawr round cairn IV (GM588) overlooking Ebbw Vale to the east

- A9.1.7. Domen Fawr Round Cairn IV consists of a large circular mound 12 m in diameter and 1.0 m in height. Truncated by modern activity, a brick and concrete structure 3.0 m by 3.0 m in the body of the cairn. Thought to be a WWII pillbox or observation post. It is in excellent condition and is considered a good example of a bronze age cairn in the area. Most likely to hold undisturbed burial remains within.

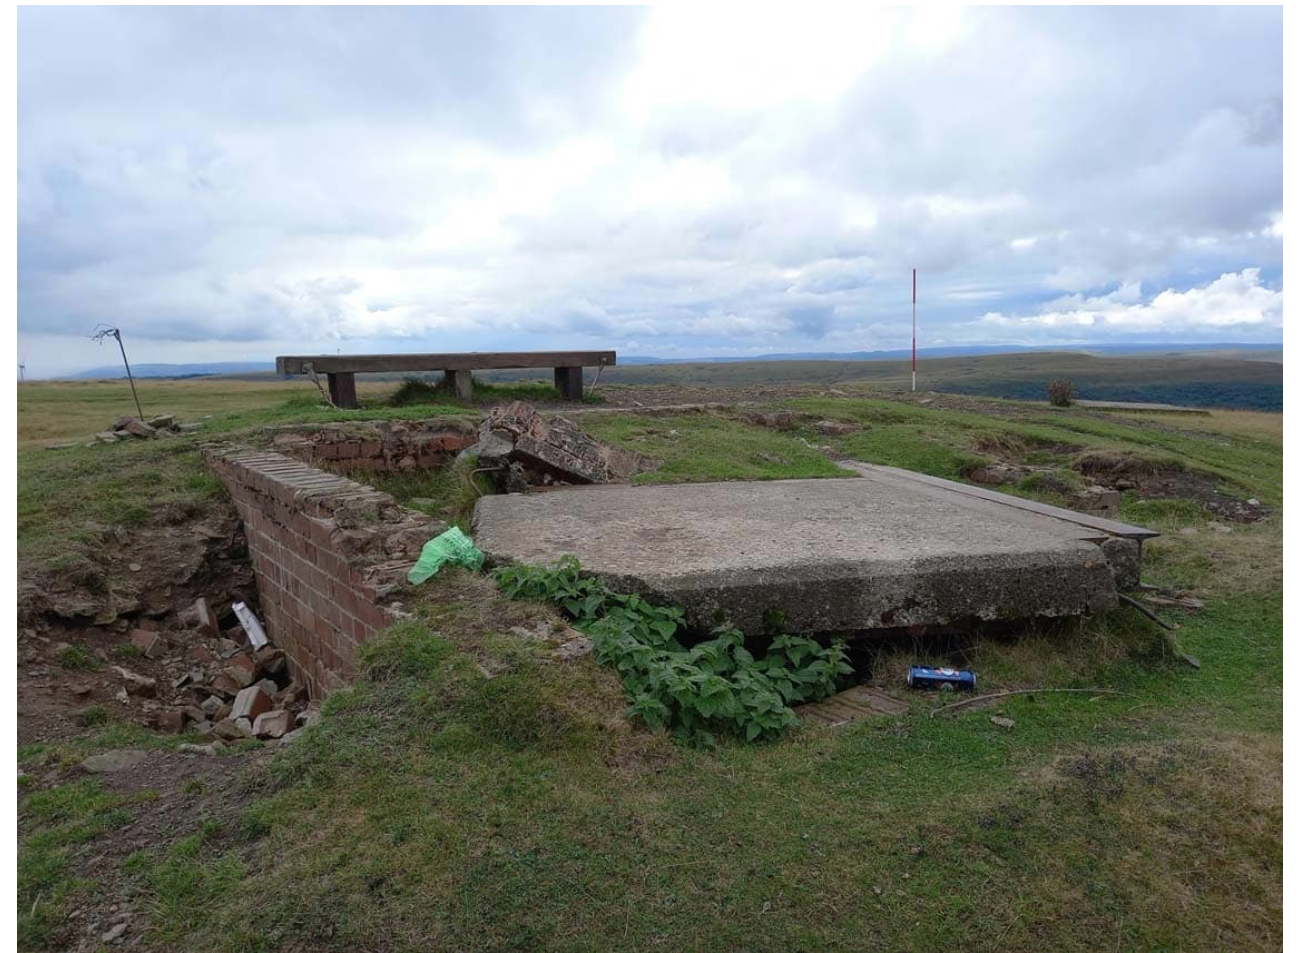
Figure A9.3.3: Domen Fawr round cairn condition of monument from the south

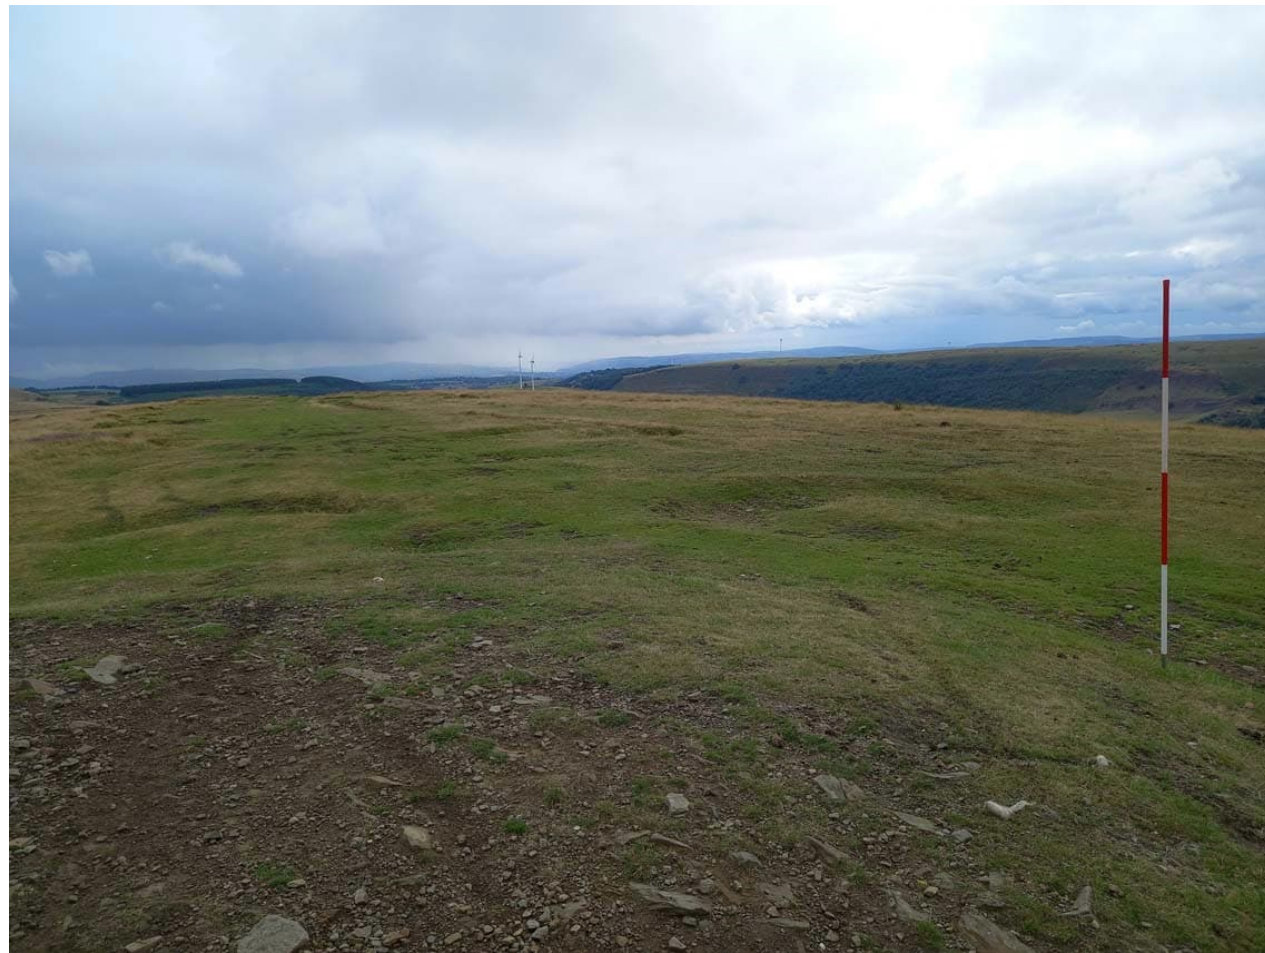
Figure A9.3.4: View to north from Domen Fawr round cairn IV (GM588)

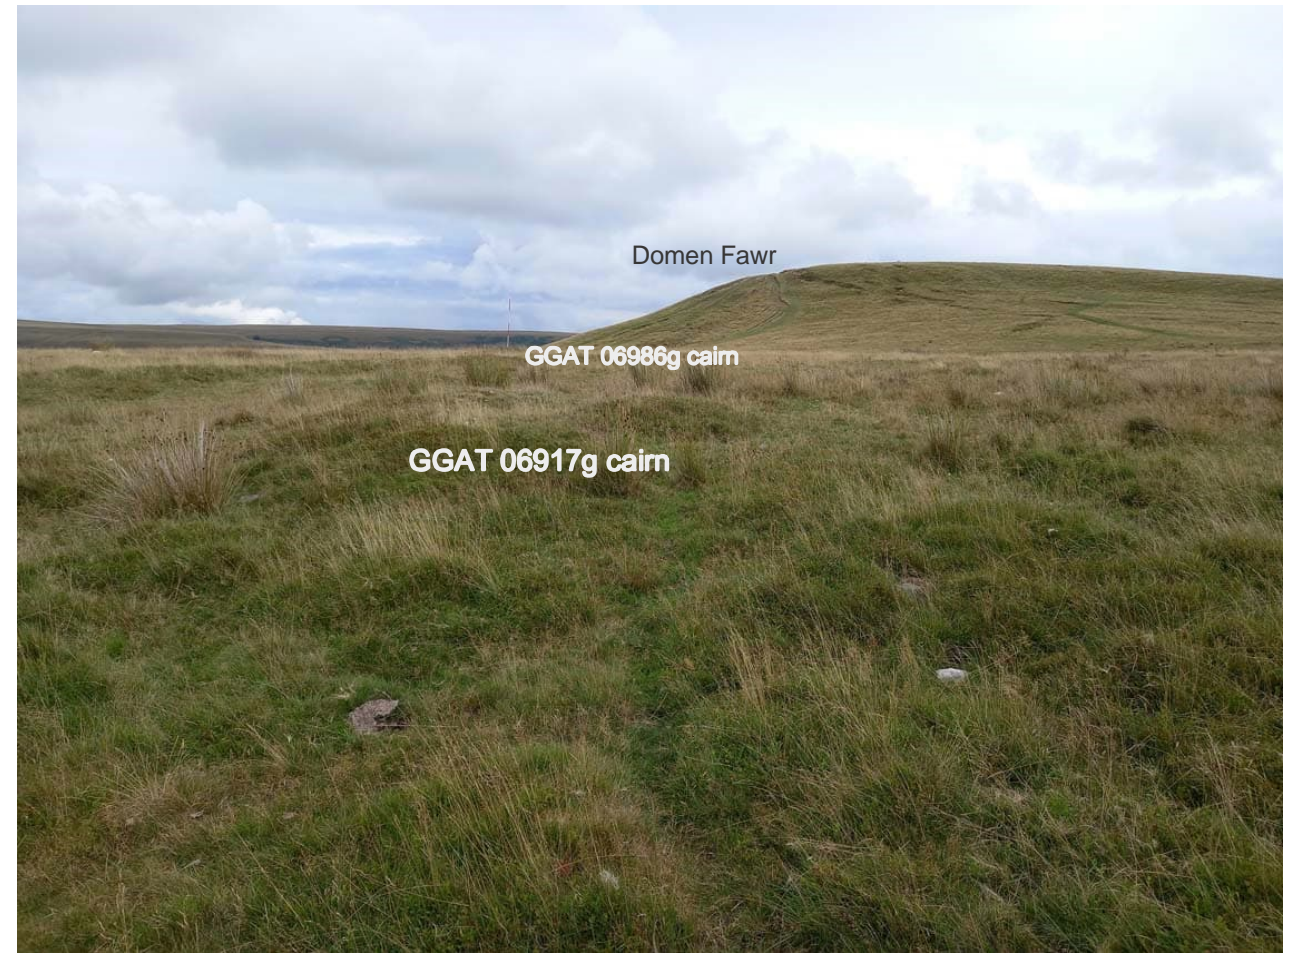
Figure A9.3.5: Domen Fawr from the west with round cairns I and III in foreground

- A9.1.4. Domen Fawr Round Cairn I is a small well-preserved cairn measuring 1 m in diameter and 0.3 m in depth which has slight truncation on the NE quadrant by vehicle erosion and features antiquarian disturbance in the centre of the feature.

- A9.1.6. Domen Fawr Round Cairn III is small well-preserved cairn measuring 5 m in diameter and 0.5 m in height. Like cairn I, it also features central antiquarian disturbance, measuring 1.0 m by 0.5 m by 0.2 m in depth across the east to west of the feature.

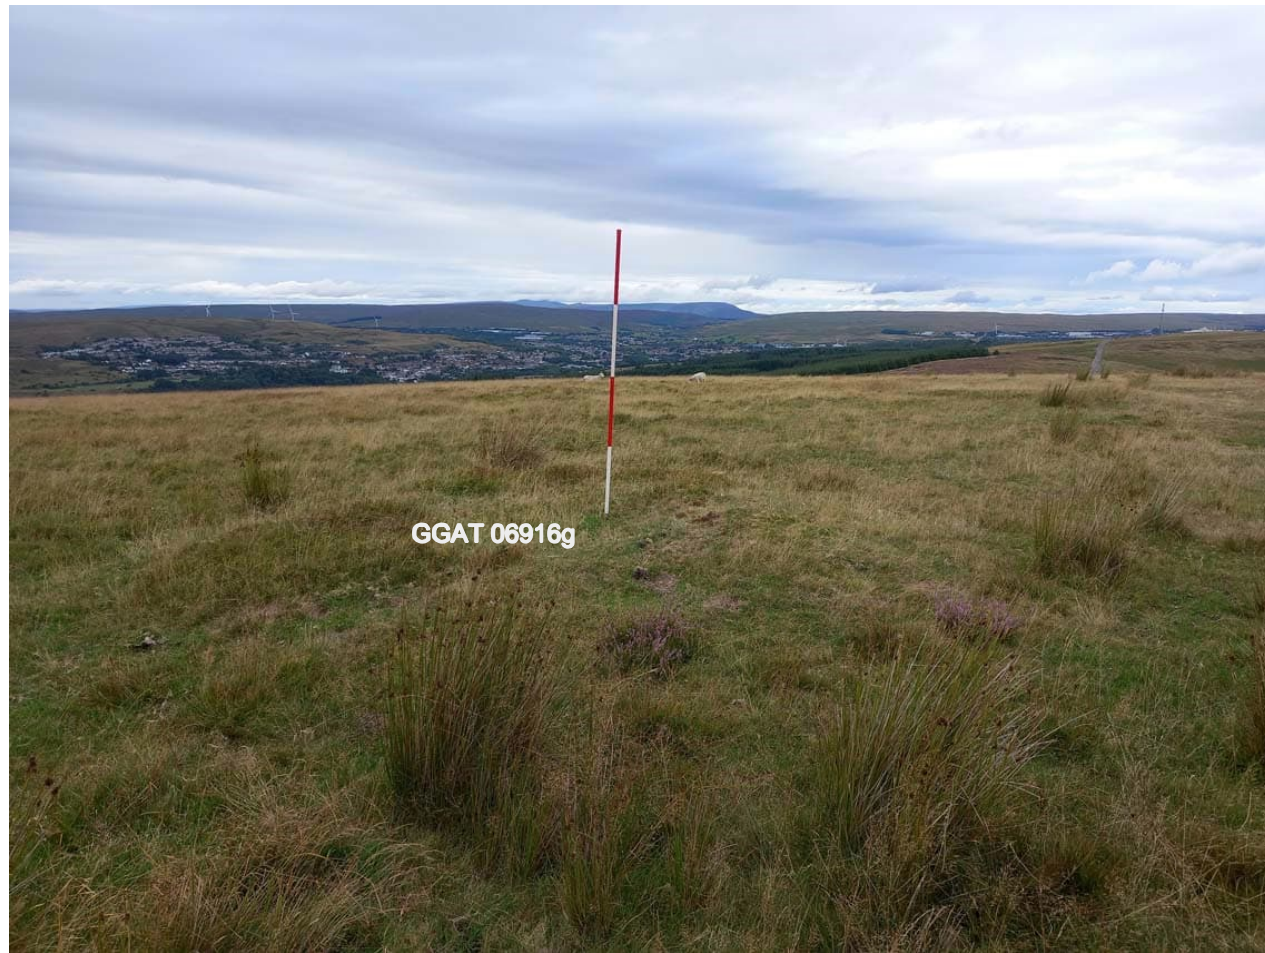
Figure A9.3.6: Domen Fawr round cairn II looking north-west to Tredegar

- A9.1.5. Domen Fawr Round Cairn II is a well-preserved cairn measuring 4 m in diameter and 0.30 m in height. Like the other cairns, it is in a prominent position above the surrounding landscape.

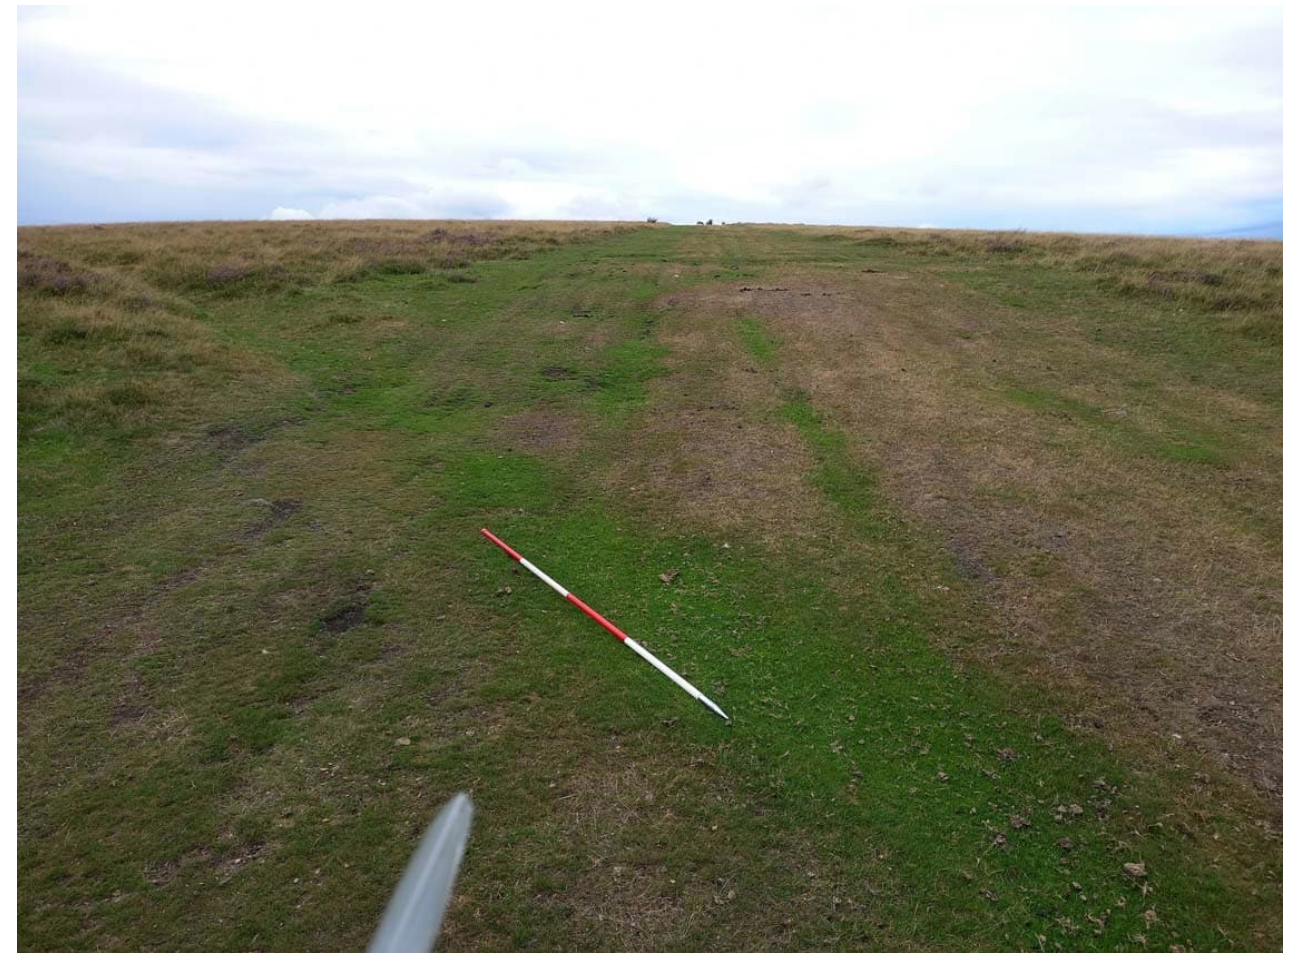
Figure A9.3.7: Boundary banks and ditches (dykes) (GGAT 08679g & 08680g) looking north

- A9.1.15. The dykes, Dyke D and Dyke C, were aligned east to west and north west to north west corner of the enclosure. Dyke C, the west to east dyke, was approximately 100 m long and flanked by ditches. Dyke D, also flanked by ditches, was aligned north west across the Cefn Man Moe ridge to the north west corner of the Cefn Man Moel enclosure. The enclosure was a rectangular enclosure formed by dykes aligned north-west to south east along the eastern edge of Cefn Moel. The banks themselves are 2.0 m wide and 0.5 m in depth and are flanked by ditches that are 1.0 m wide and 0.25 m in depth.

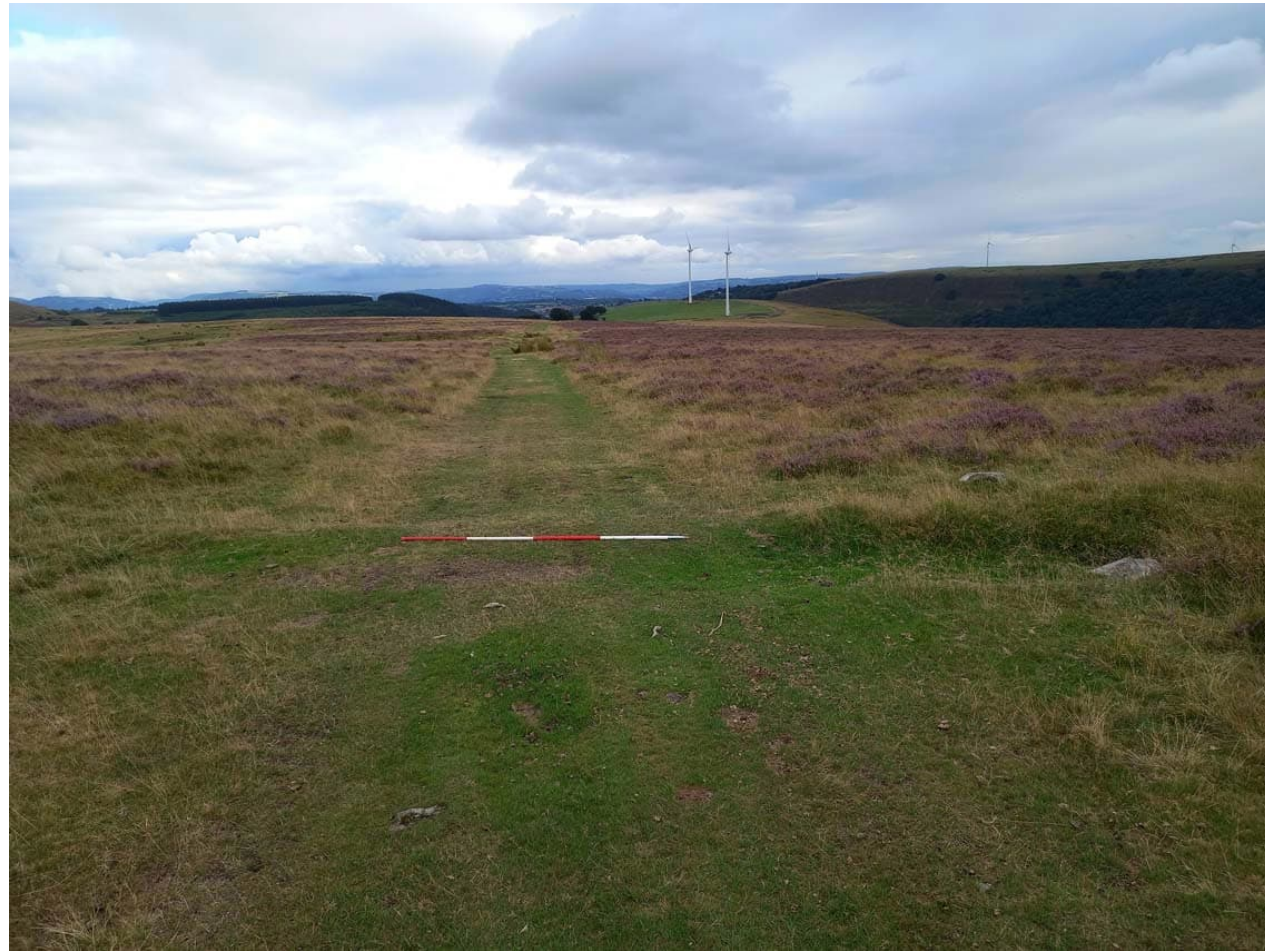
Figure A9.3.8: Cefn Manmoel cross-ridge dyke (MM345) (GGAT08677) looking south

- A9.1.14. The medieval features identified in the area appear to be centered on top of the hill separating Tredegar from Ebbw Vale. It is Cefn Man Moel enclosure and its associated dykes and boundary stone. The boundary stone is described as being an earth fast boulder, approximately 1 m length x 0.5 m width x 0.5 m in height, that is in the north west corner of the enclosure. It is thought to have been used to direct cattle into the enclosure.

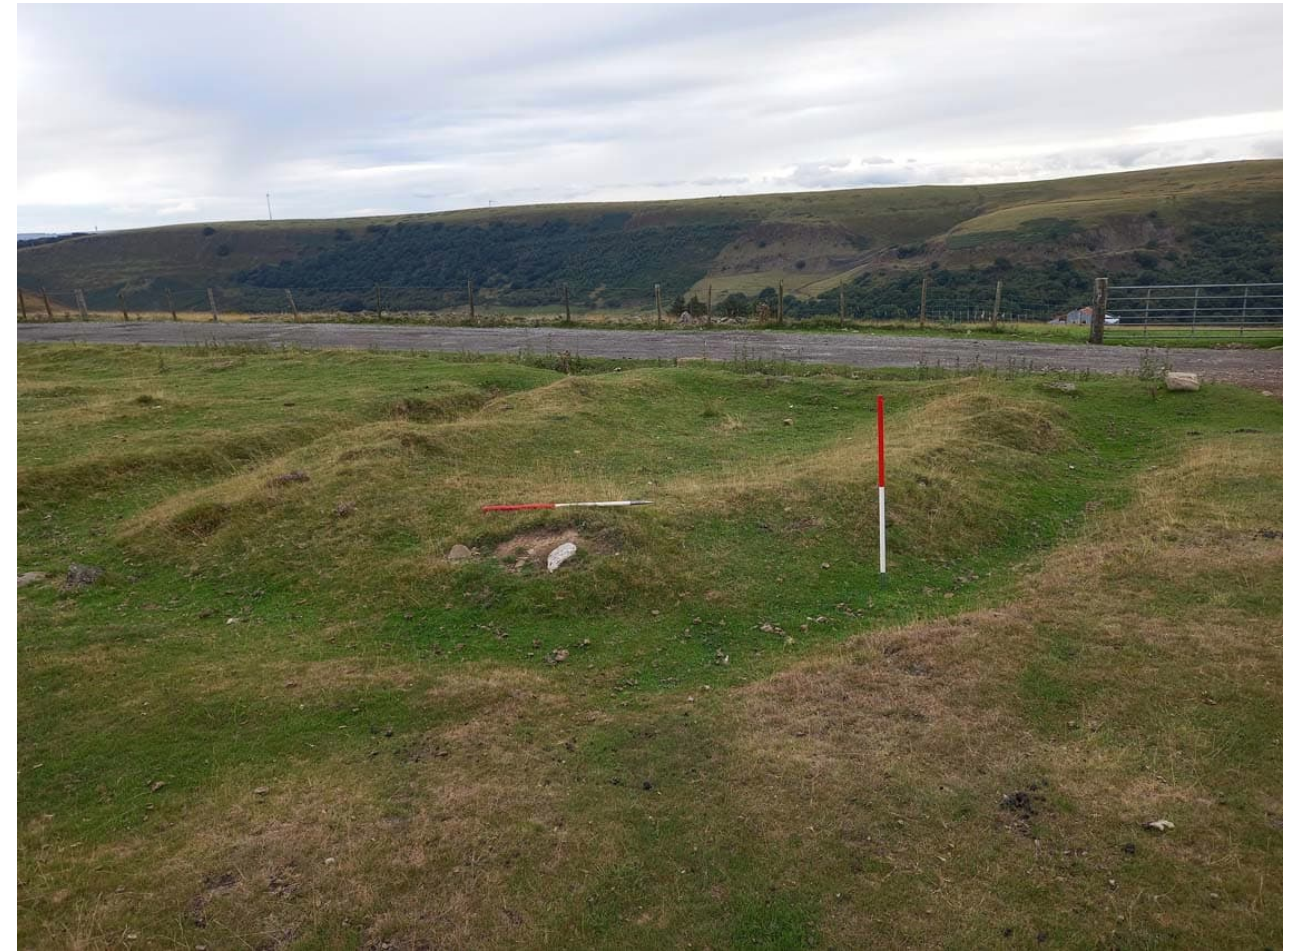
Figure A9.3.9: Earthwork remains of building (GGAT06987g) looking west
